Accelerator Operations Summary

R. Dixon

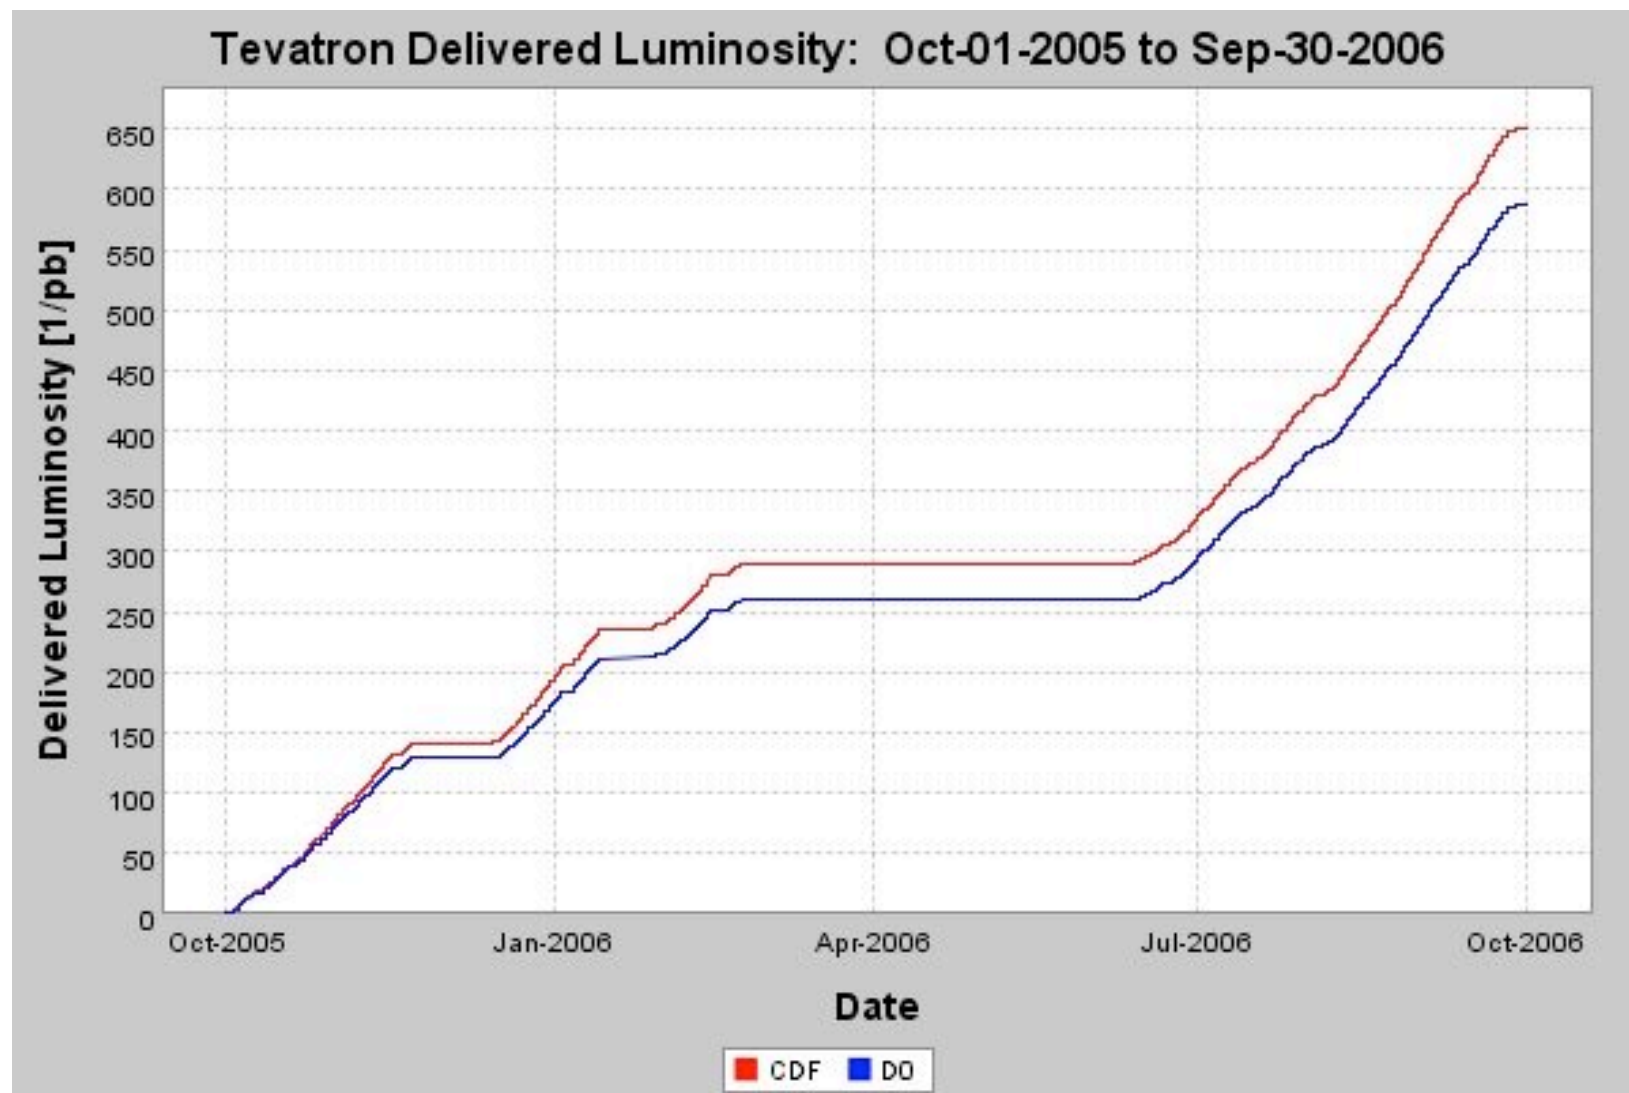
FY06 Integrated Luminosity

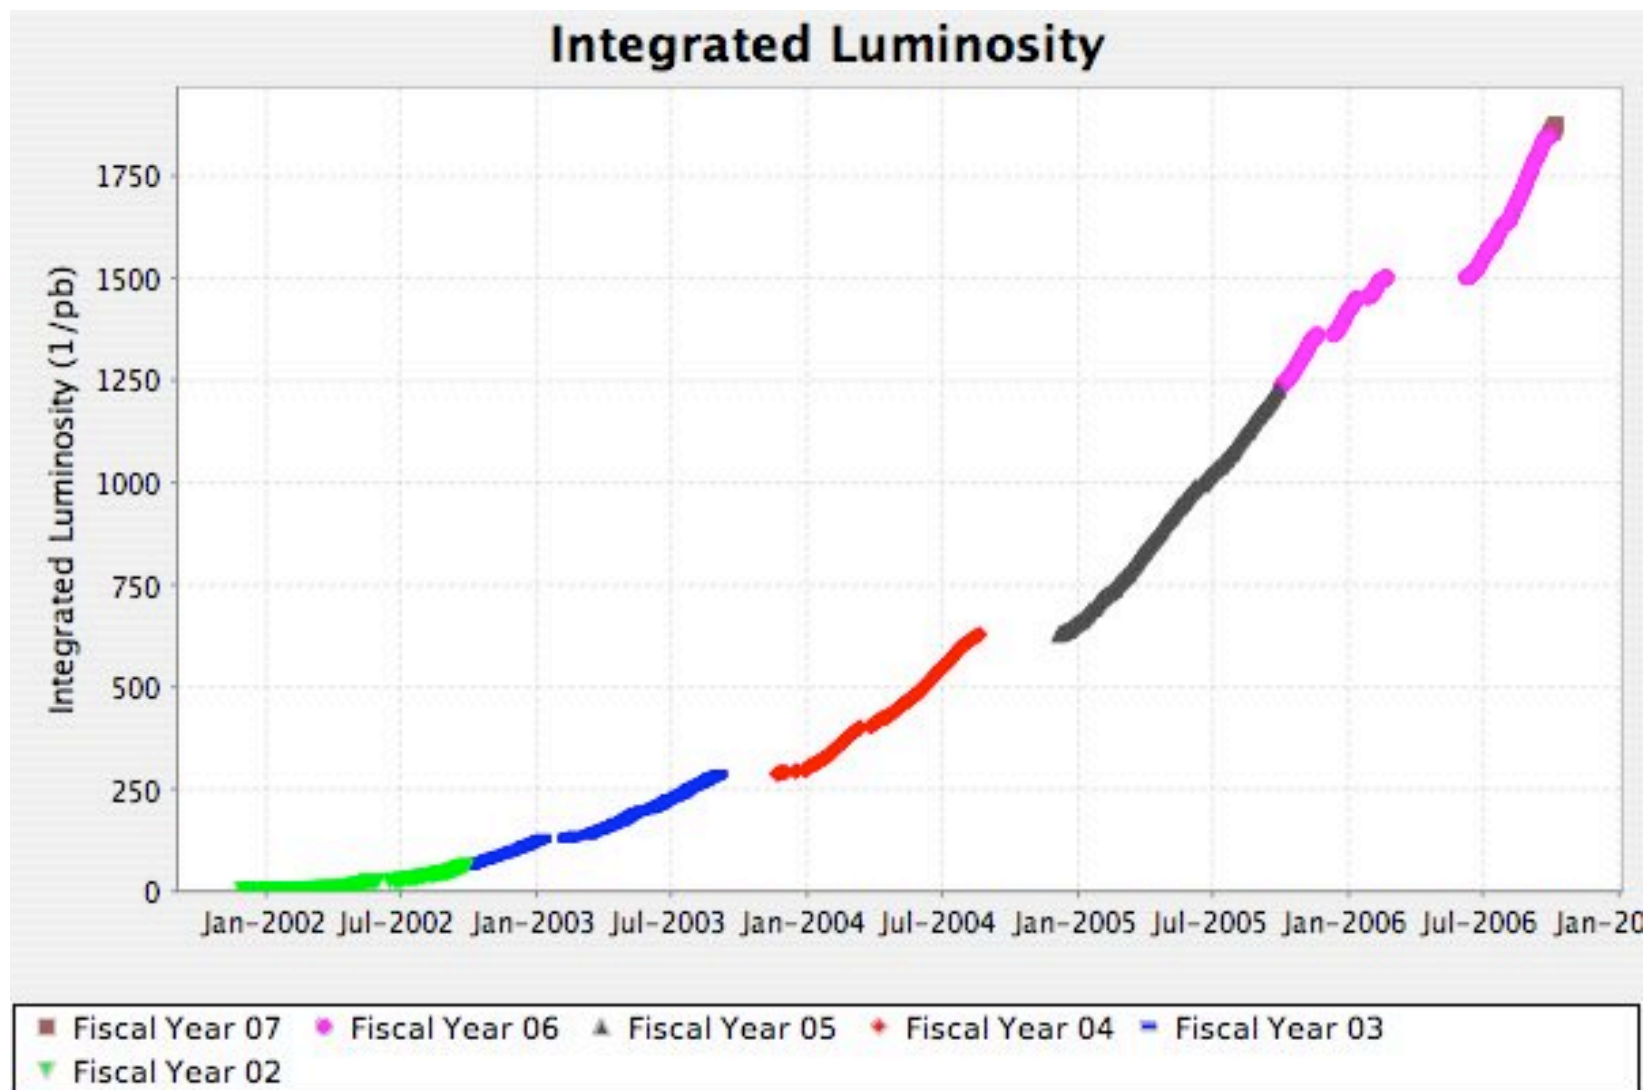
Total Integrated Luminosity for Run II

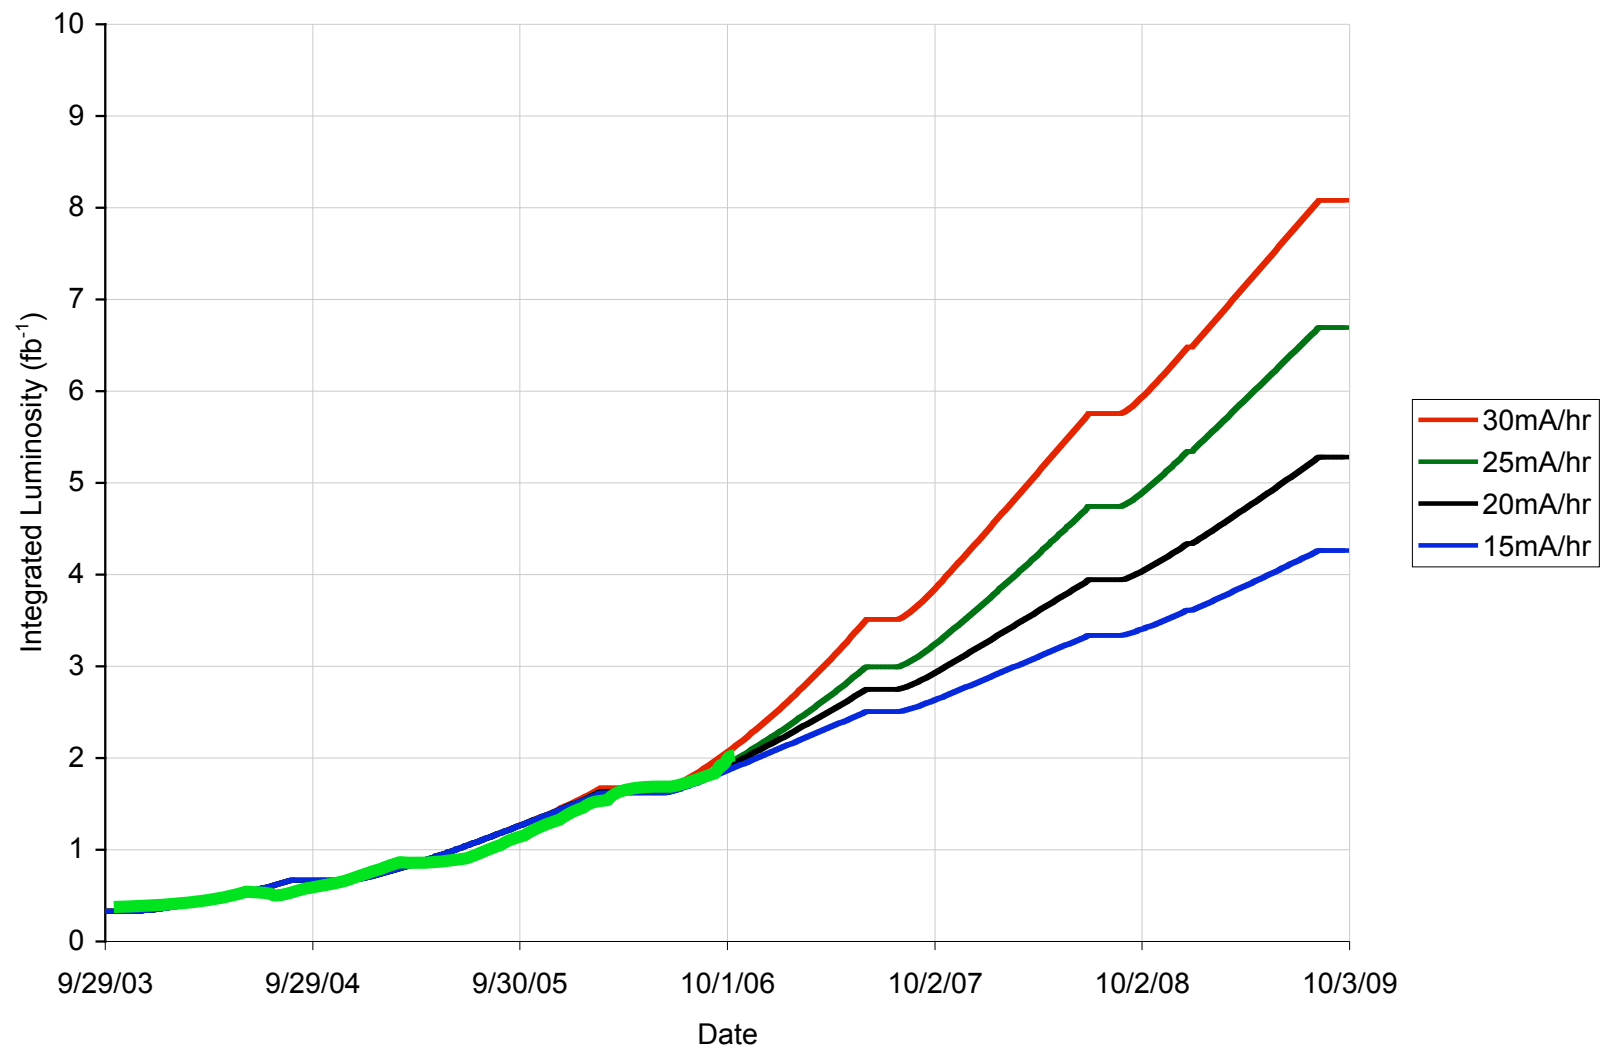
Current Luminosity vs Projections

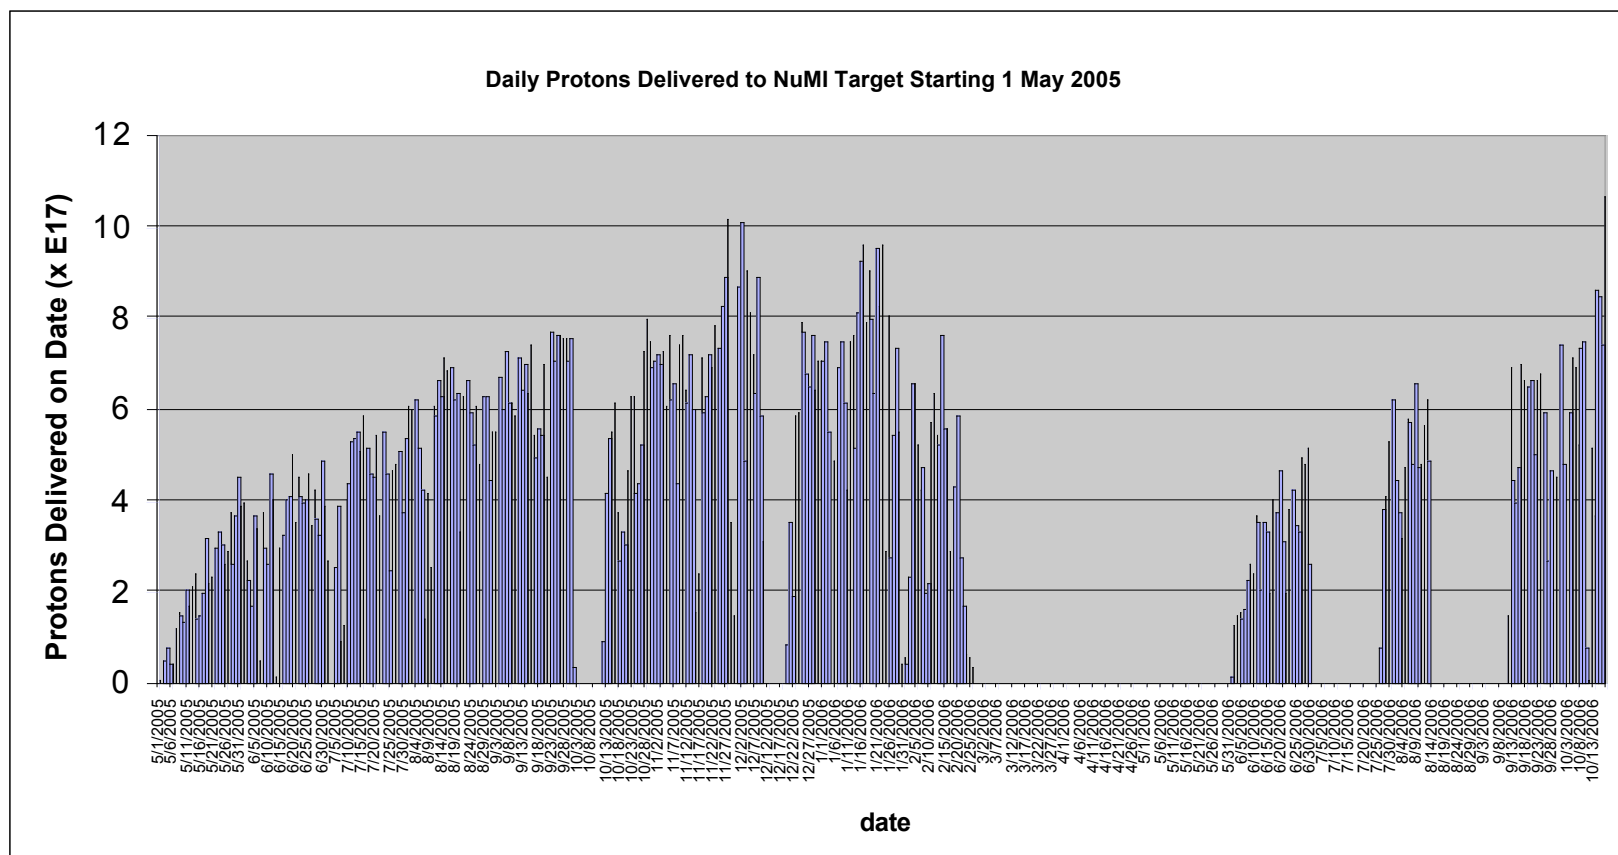
NuMI Daily Protons on Target Total 1.781E20

1.069E18 Protons delivered Oct 17' 06
New NuMI Record

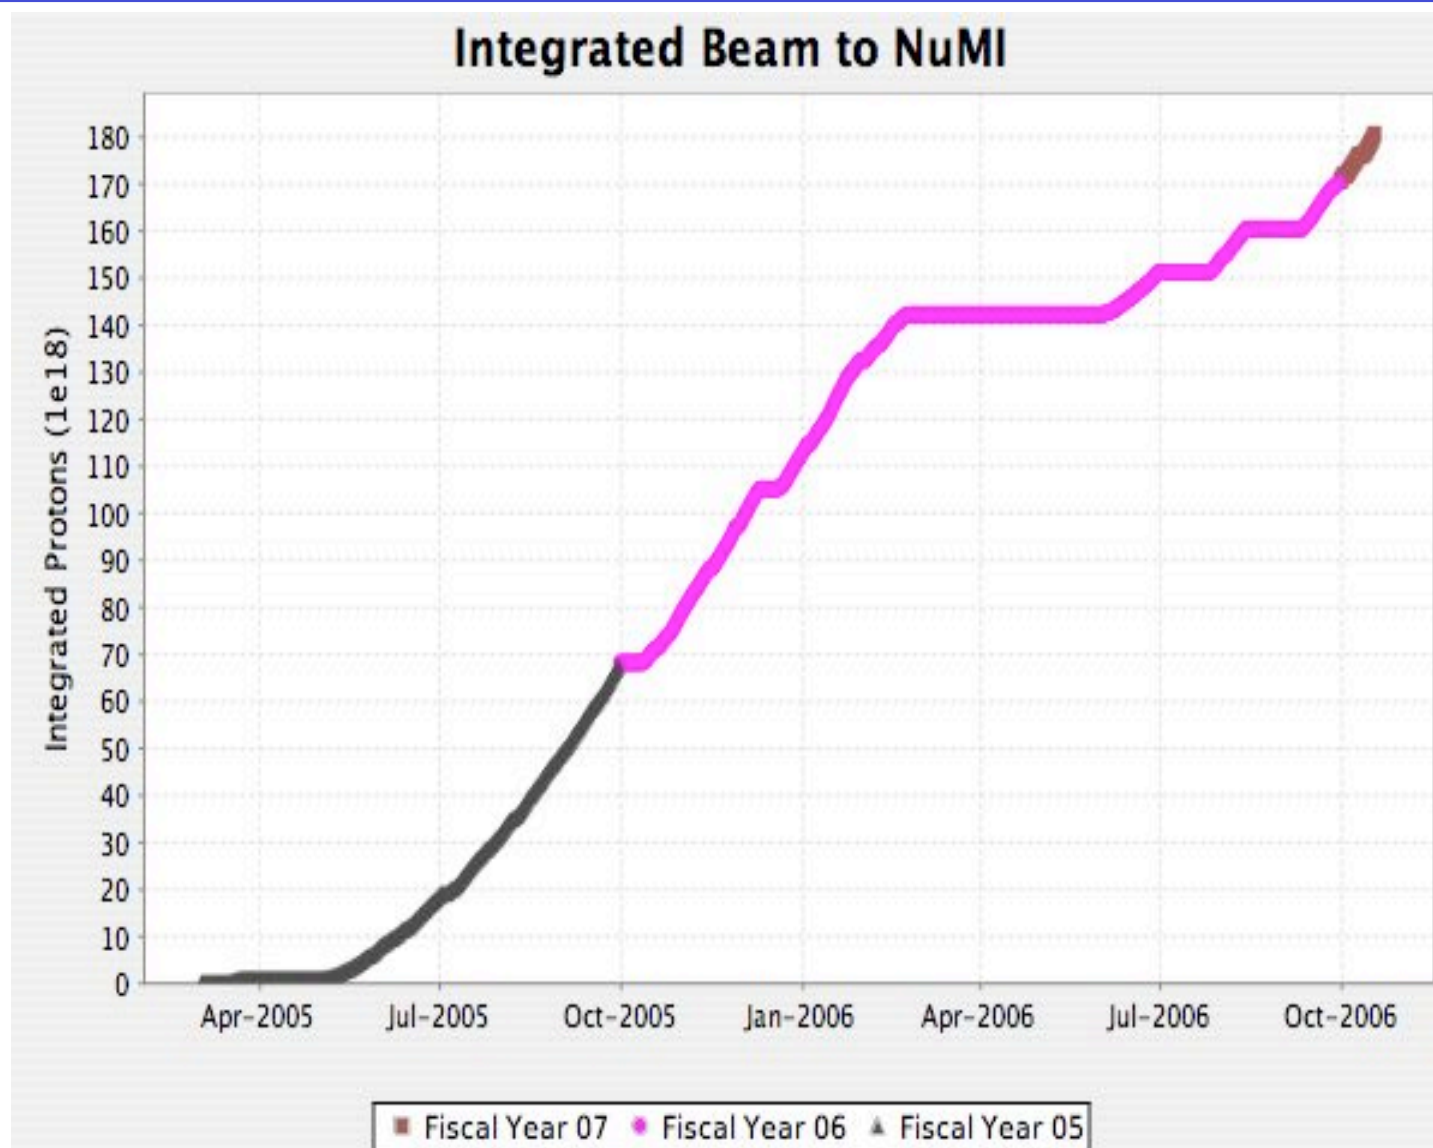
Total Protons to NuMI

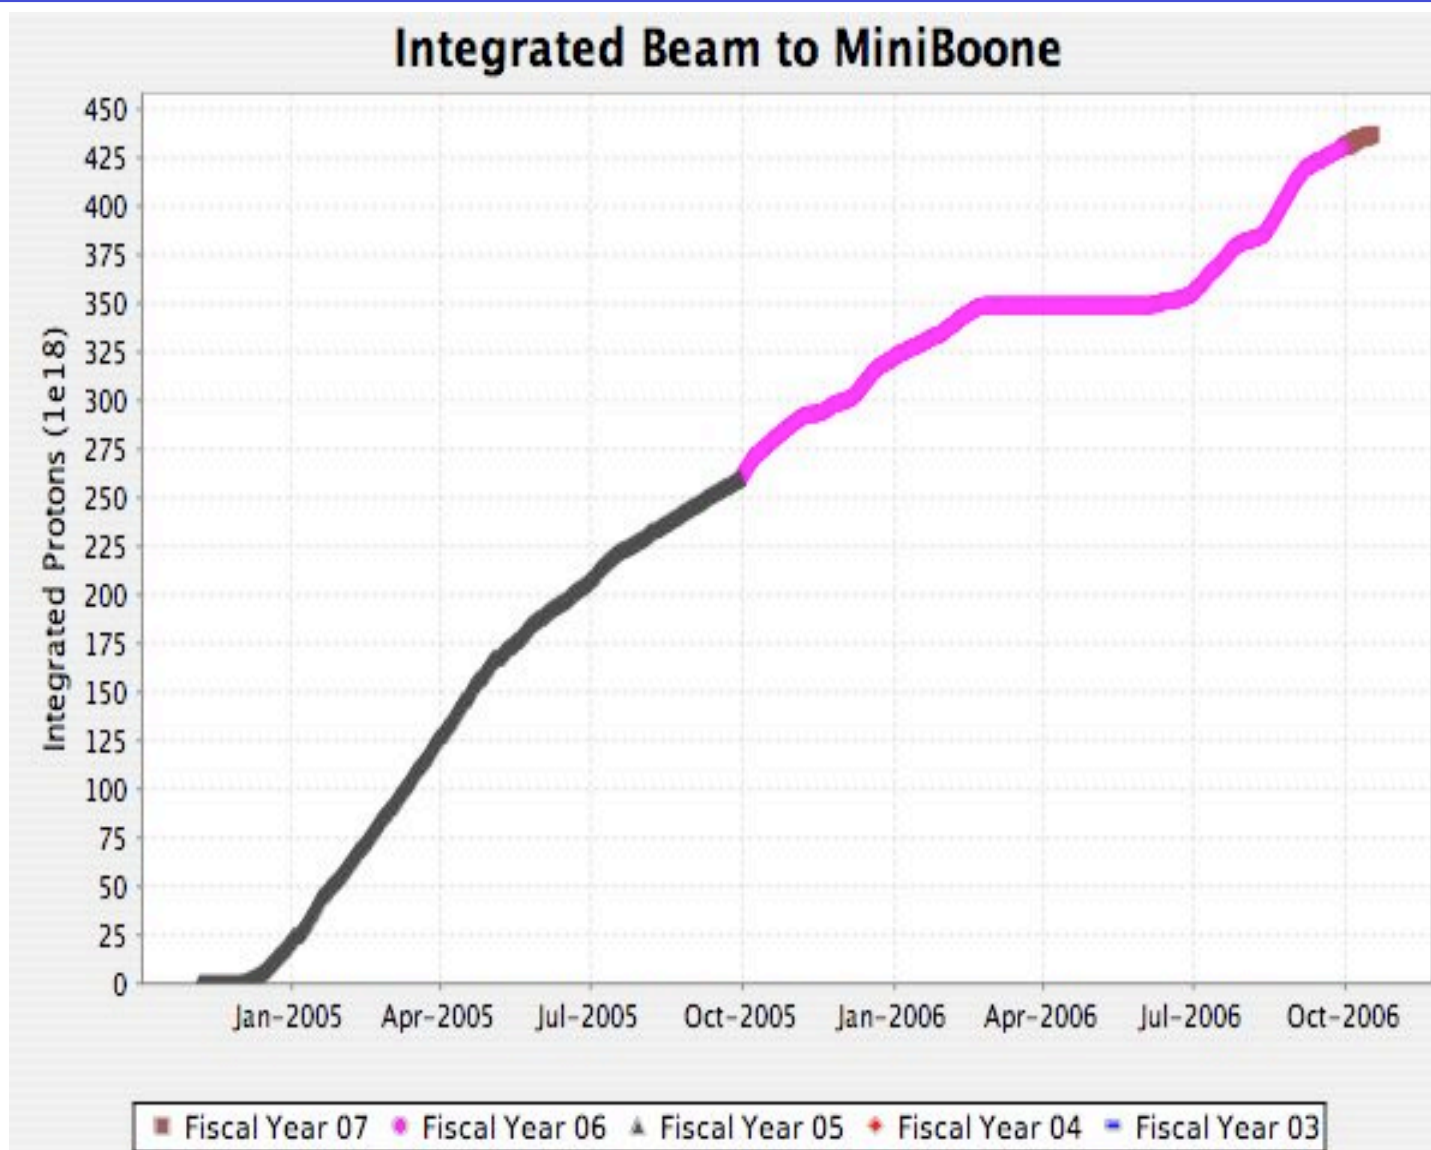
Total Protons to MiniBooNE

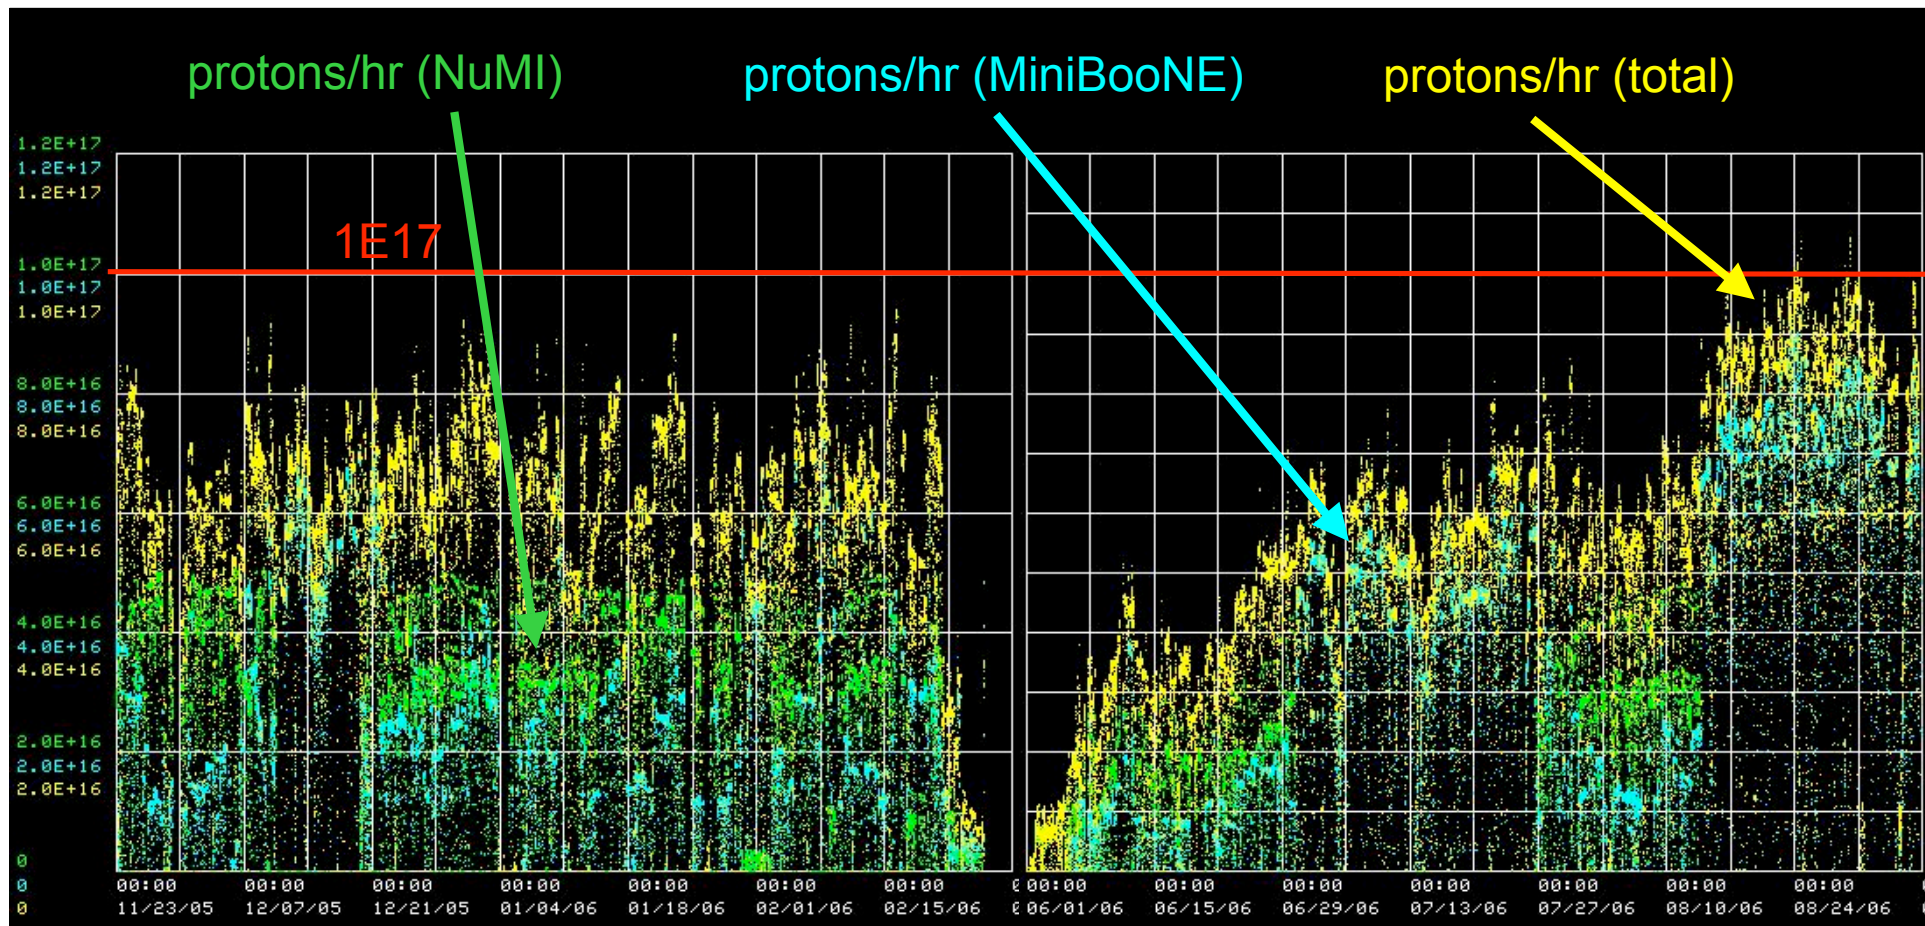
Hourly Rates

Before Shutdown

After Shutdown

- Better Injection matching
 - Beam motion reduced from 1 cm to ~2mm
- Record efficiency -> Record performance
 - Hourly rates
 - 9E16 pph MiniBooNE
 - 1E17 pph total
 - Weekly totals
 - 1.08E19 to MiniBooNE
 - 1.2E19 total
- Note: nothing that was done in this shutdown was expected to significantly increase beam to NuMI. That will come from
 - Increased up time
 - Reduced average MI cycle time
 - Slip stacking (fully operational after next shutdown)

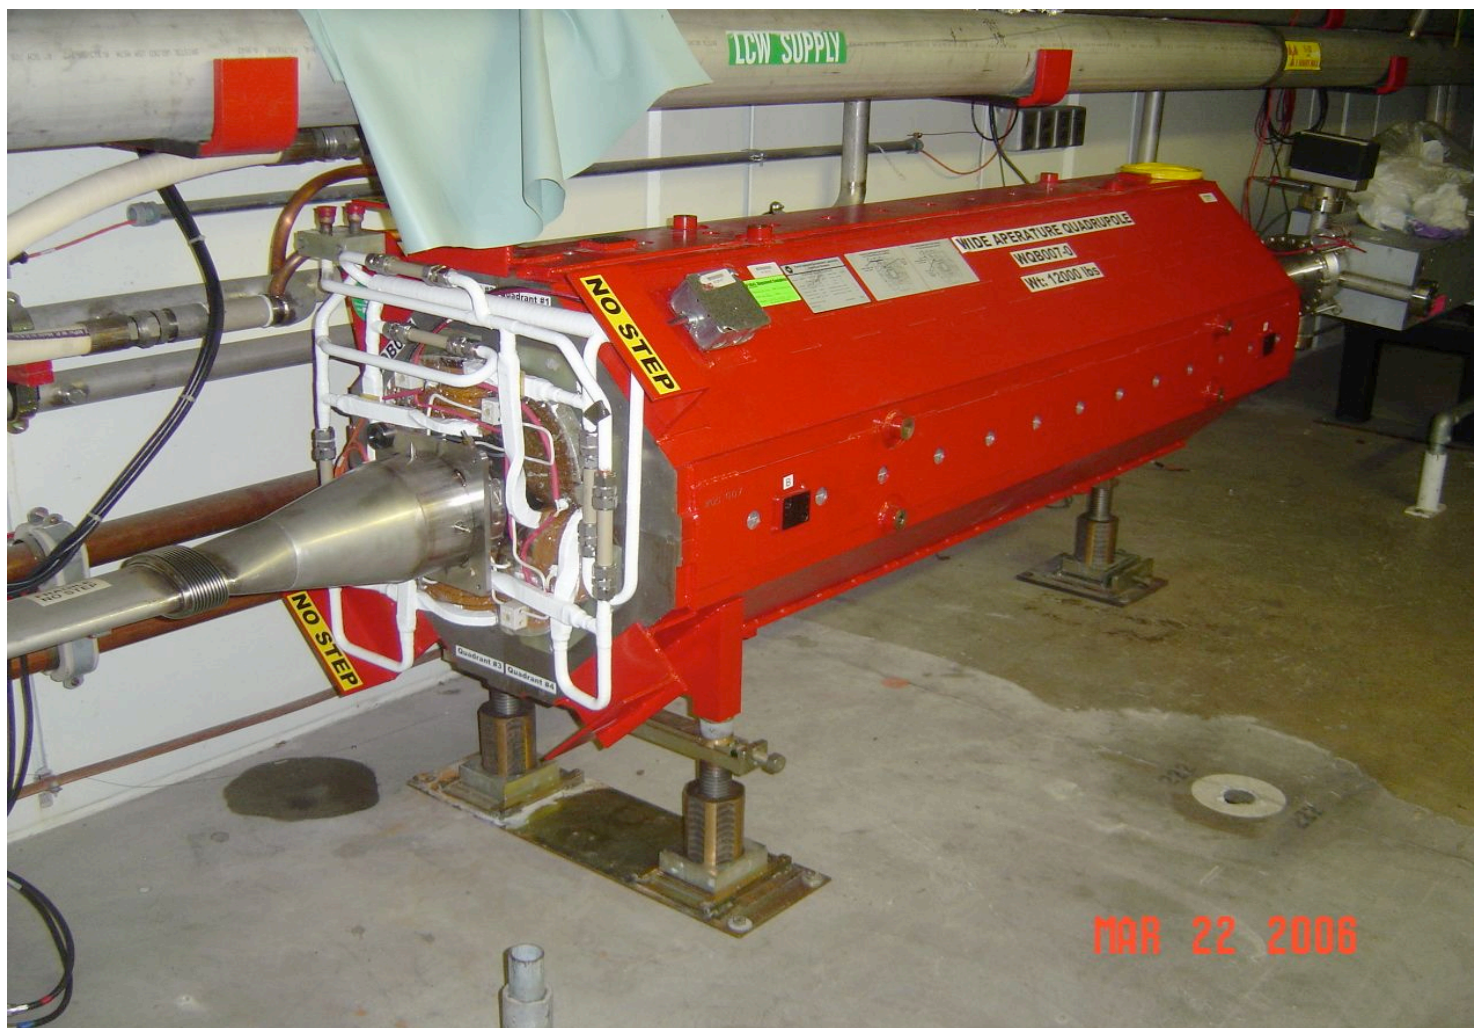
One the 7 Installed large aperture Quads (Q222)

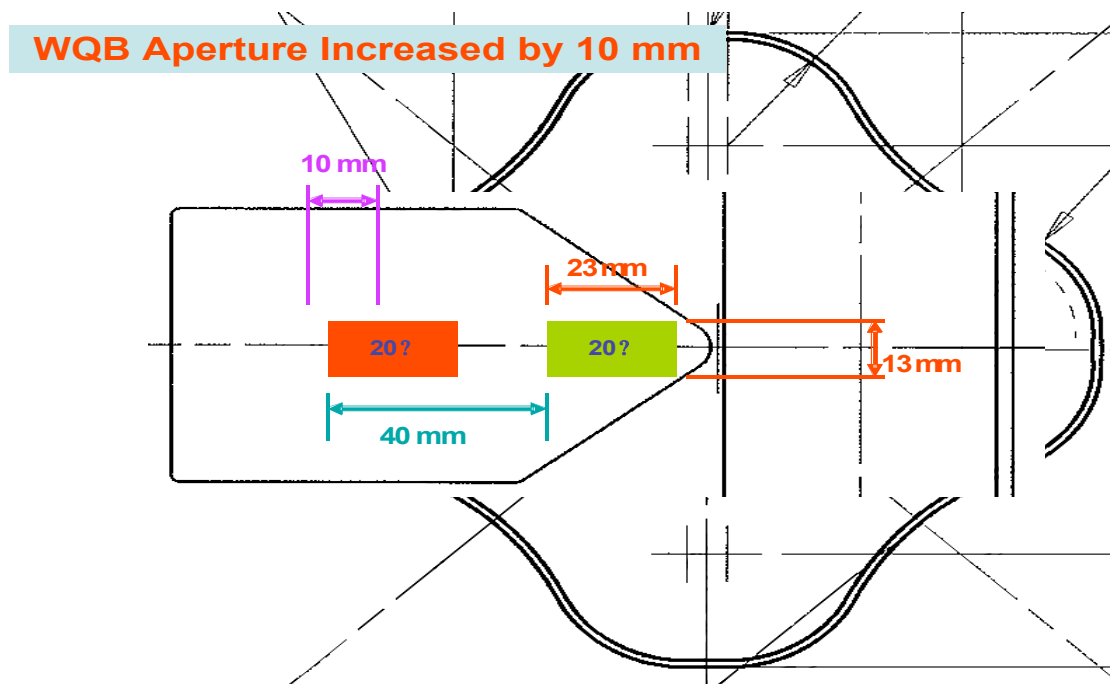
Aperture Increase

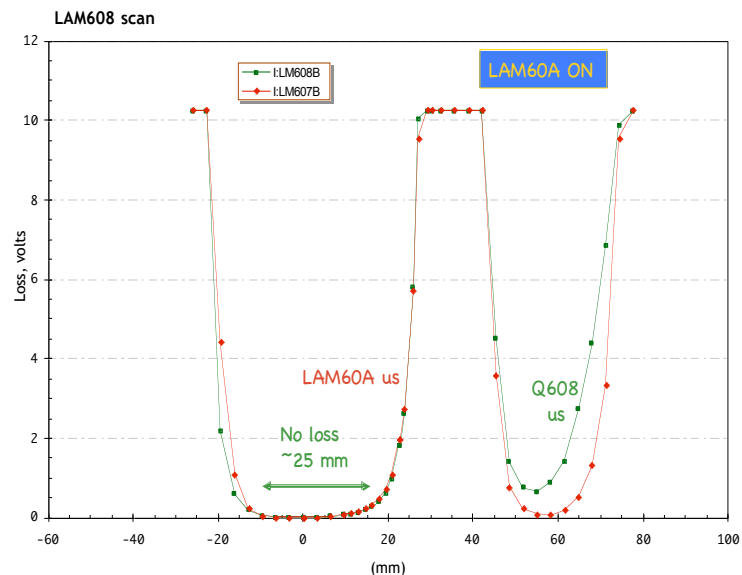
MI608 aperture scan, before shut-down

Aperture scans at one of the WQB Locations

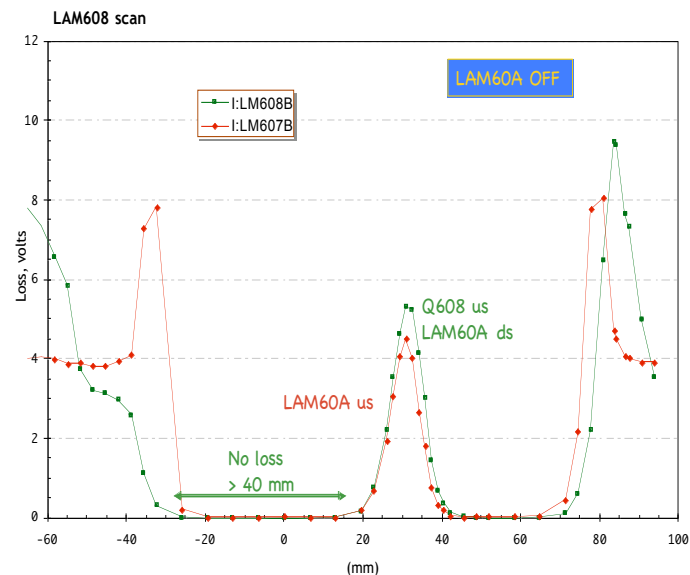
MI608 location aperture scan, now

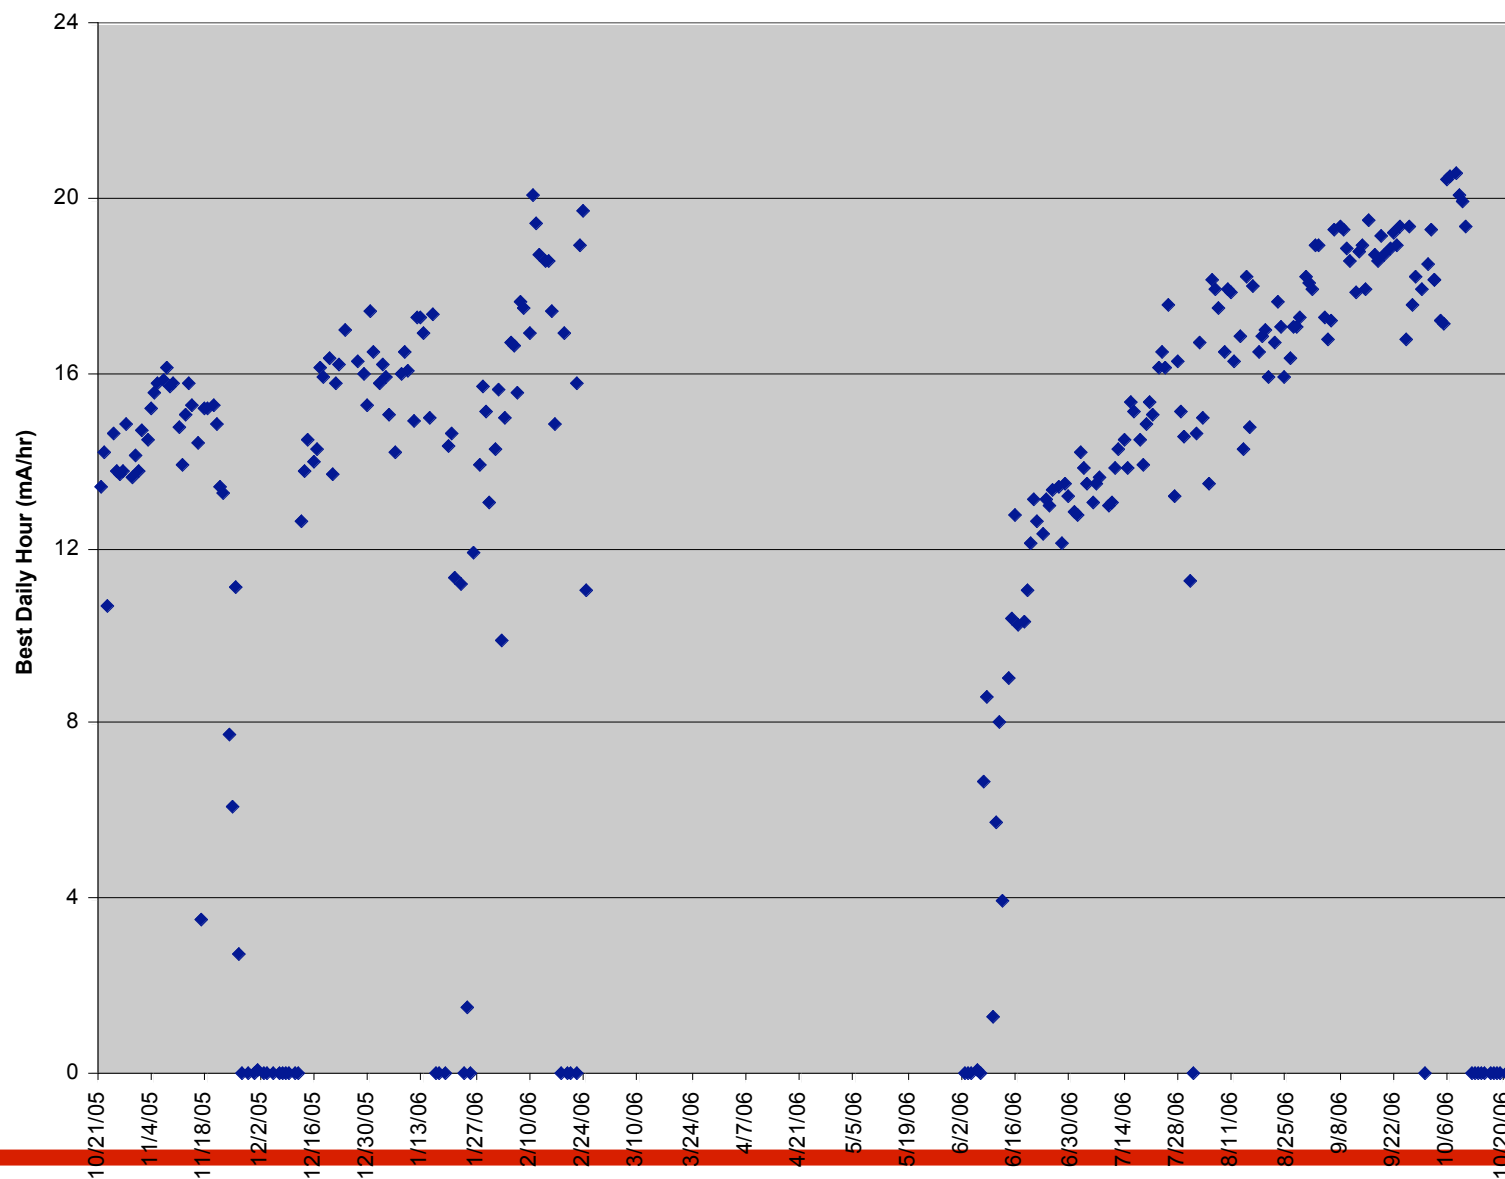
Best Hour of Stacking Each Day

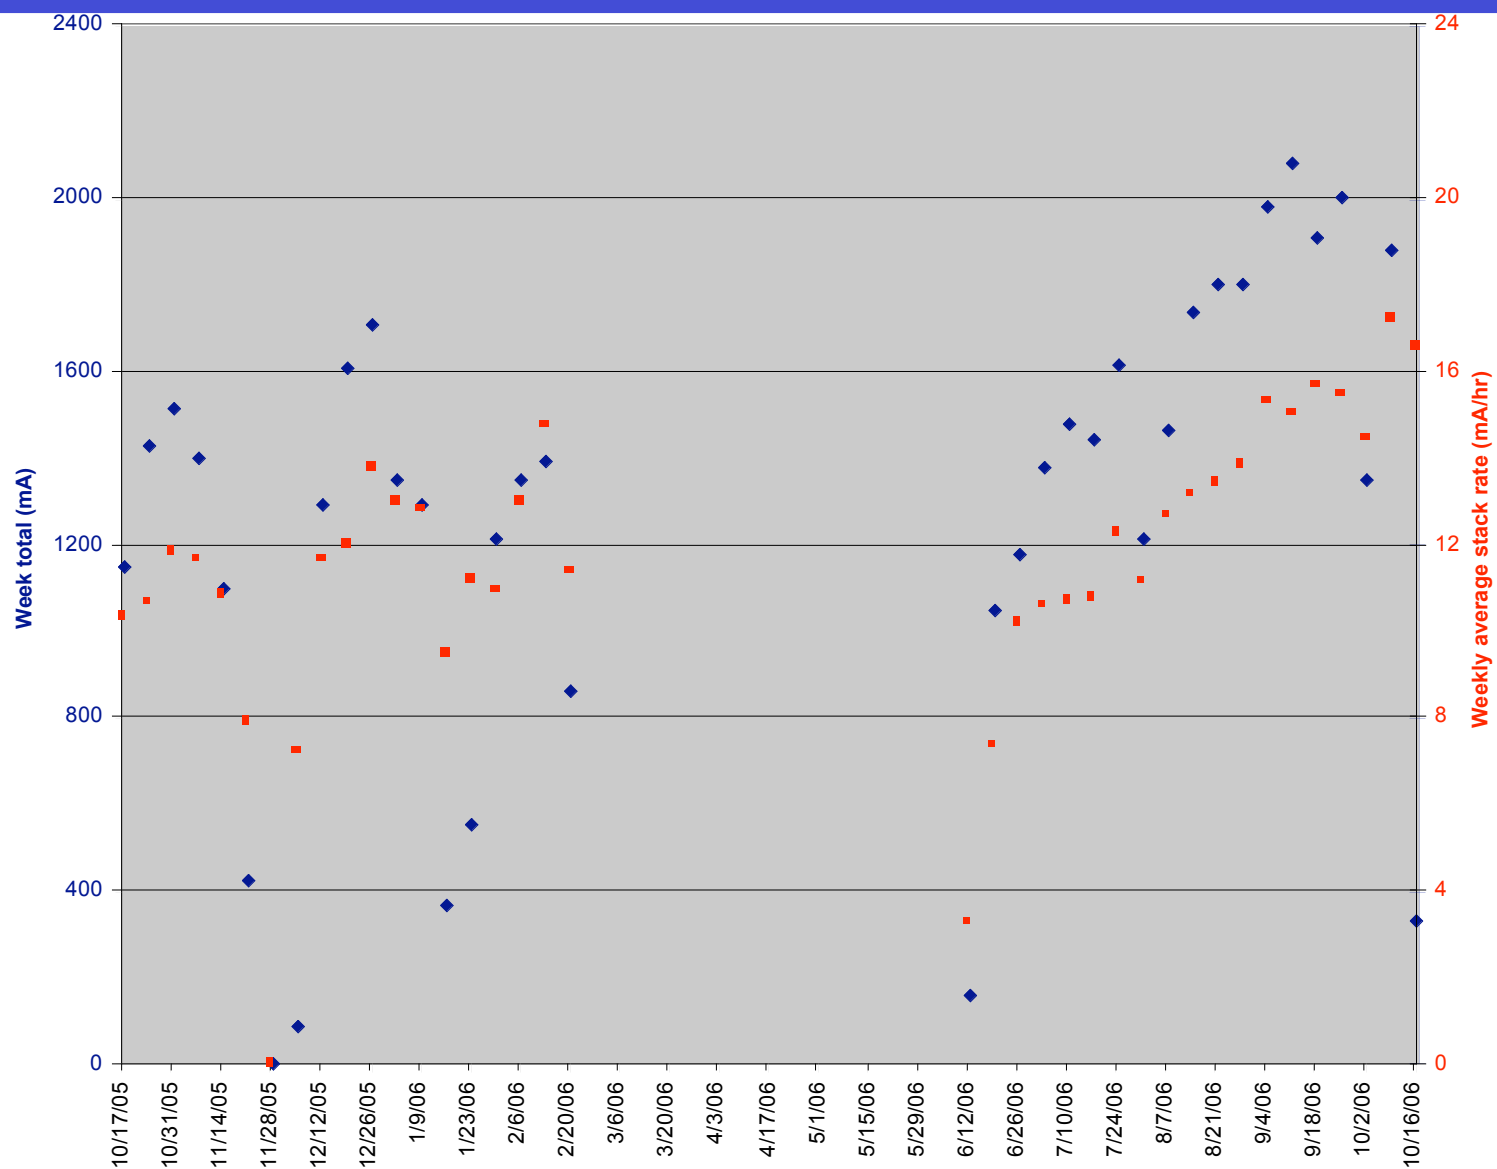
Antiproton Source Weekly Numbers

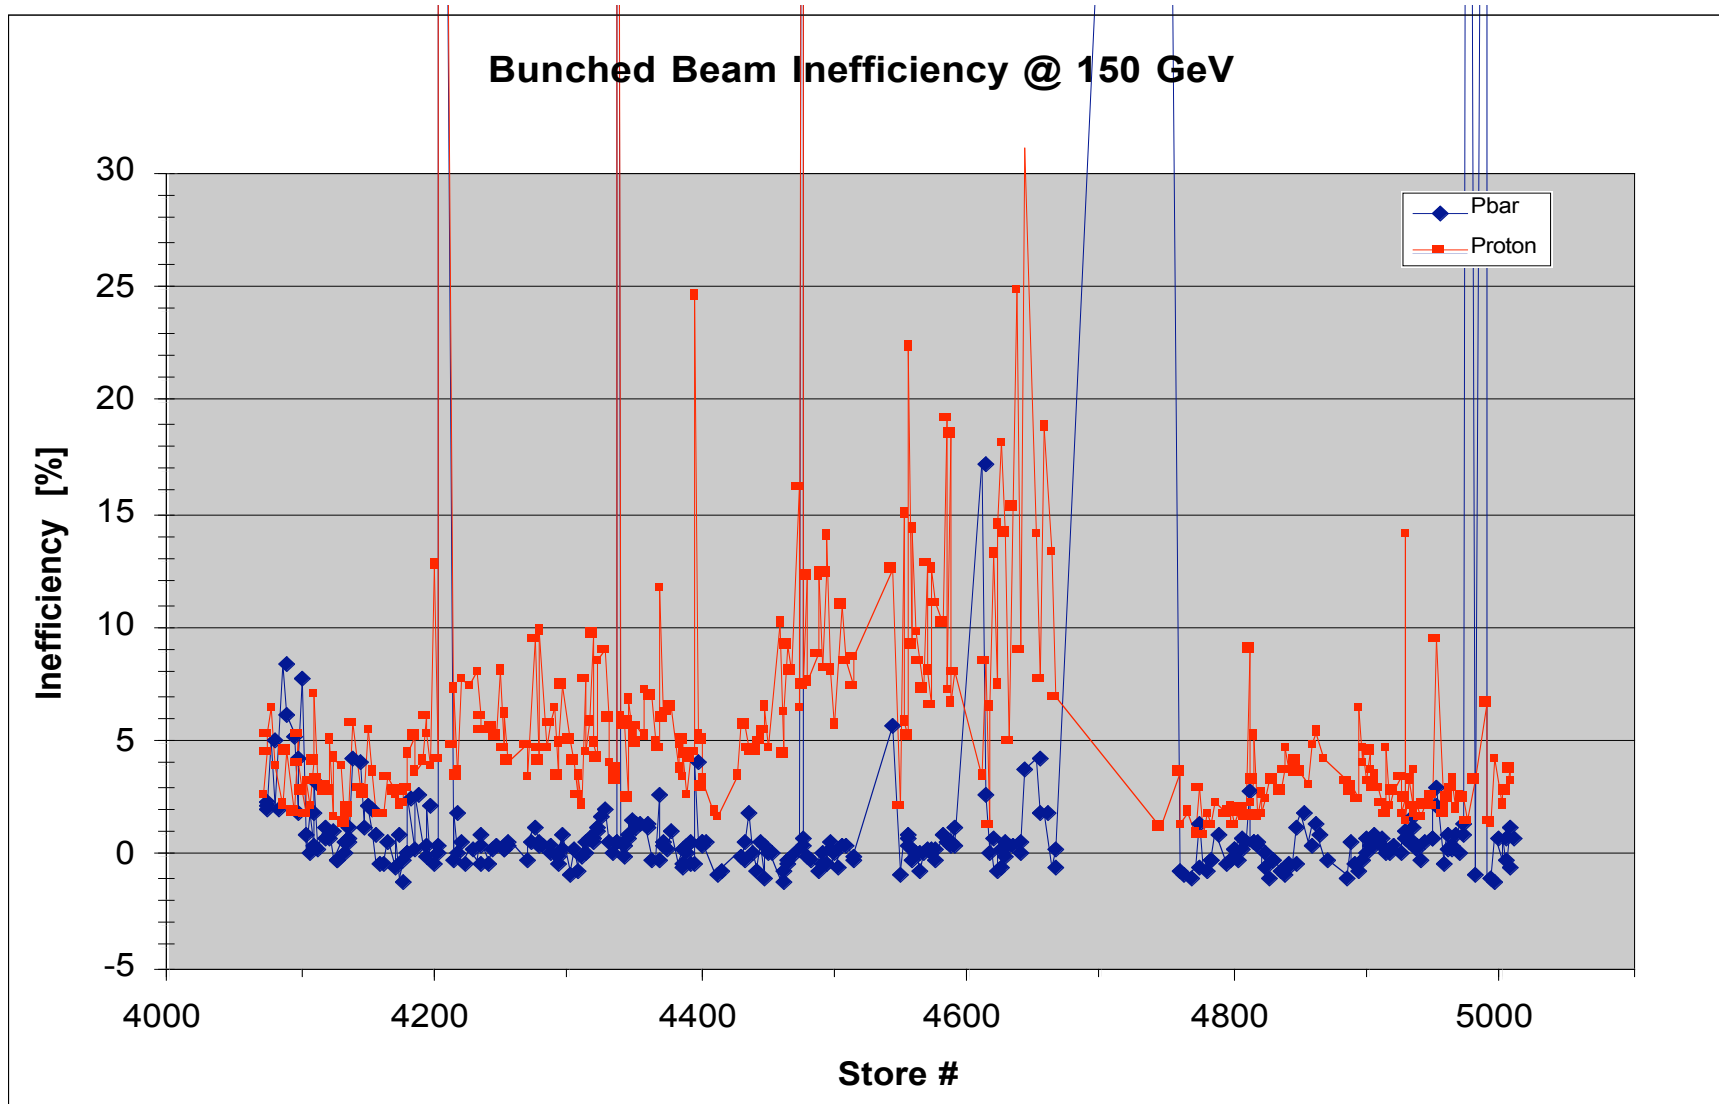
Reduced Tevatron Beam Loss @ 150 GeV

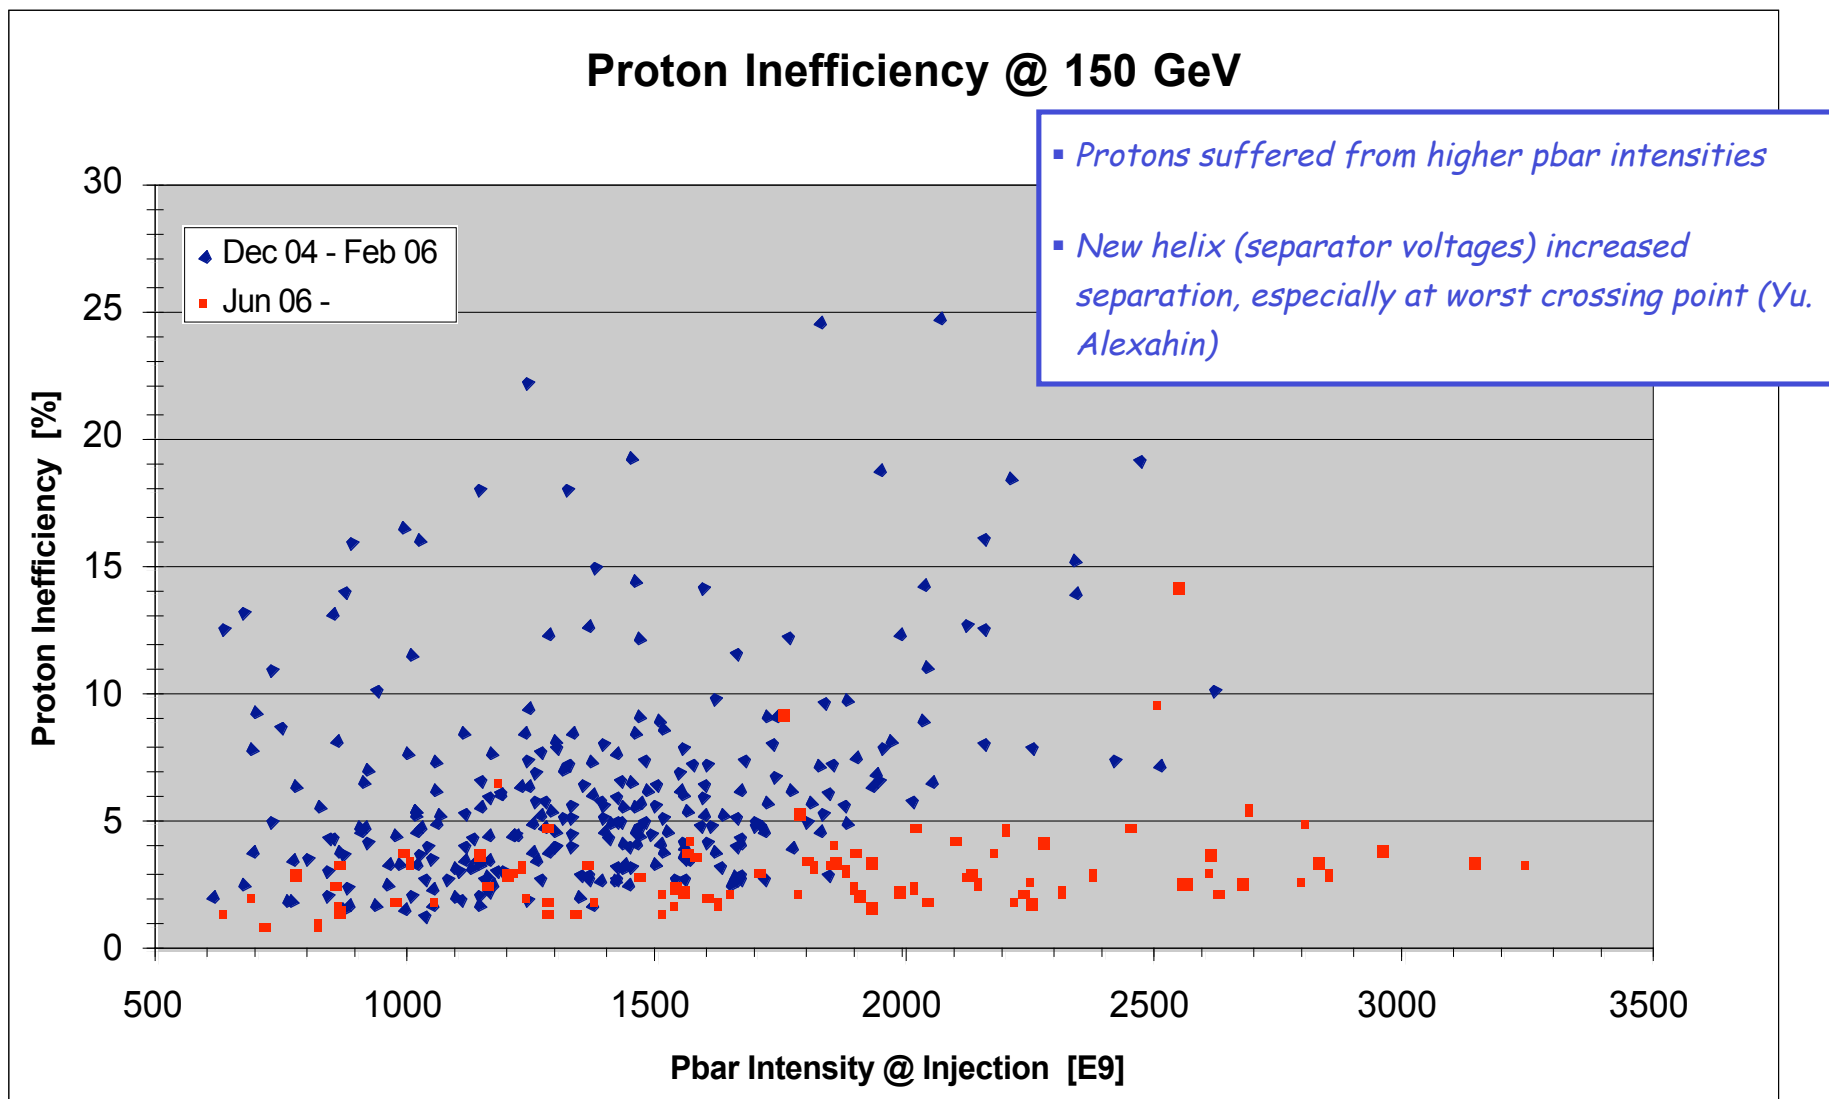
Reduced Beam-Beam Effects @ 150 GeV

- Long-range beam-beam effects degrade luminosity lifetime + integral
 - Nearest parasitic crossings (≈ 59 m from IPs) especially bad
- During shutdown, additional separators installed to increase separation
 - More separation \Rightarrow reduced beam-beam effects

- $\sim 20\%$ increase @ upstream IP
 - Not as much @ downstream IP
- Luminosity lifetime improved $\sim 20\%$ compared to pre-shutdown running
 - Increased integrated luminosity per store (for given store length)
